### Lynx Time Code Module Circuit Board Modifications

DATE: 03/10/94  
MODEL: Lynx Time Code Module  
REVISION: All  
SERIAL NO: Serial numbers below 3280\* (See Description)

This procedure permanently converts the REV. A version of the Lynx Module's main PCB to use 256k PROMs instead of the 128k PROMs originally installed in early modules. Once this procedure has been completed, the module cannot use 128k PROMs; all current software versions are available on 256k PROMs.

\* This Service Bulletin brings Rev. A PCB's (Serial No. 0769 and below) up to current specification, and details changes that apply to boards with Serial Numbers up to 3280. Review each modification to see if it applies to your PCB.

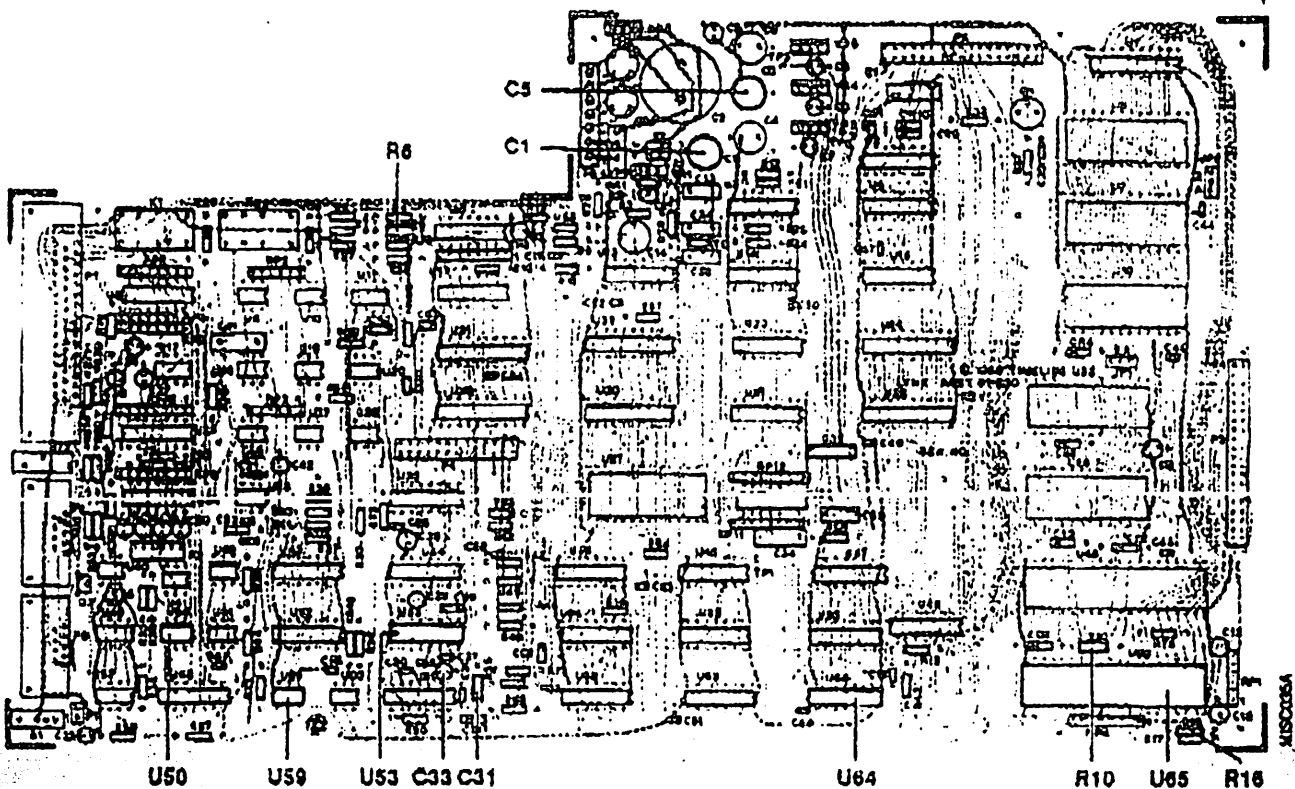
Figure 6. Component Location Step I, 8 and 9 through Step II, 1 - 5

If the resistance in 230 volt selector position is approximately 70  $\Omega$  instead of 175-185  $\Omega$ , reverse the connection of the two black wires attached to the voltage selector switch and reinsulate the connections with shrink-tubing. Then retest the module.

- a. Remove the 8256 chip from U65 on the main PCB.
- b. Bend Pin 12 of the chip outward so that it will not go into the socket.
- c. Reinsert 8256 chip in U65 on the main PCB with Pin 12 not inserted into the socket.
- d. Attach an insulated wire jumper to Pin 12 of the 8256 chip.
- e. Attach the other end of the jumper wire to the leg of resistor R10 (8.2 k $\Omega$ ) that is closer to the front of the module.

- a. If H11G2 optoisolator is found at U59 on main PCB, replace it with a 4N37 optoisolator.

- a. Examine tantalum bead capacitor C33 (1  $\mu$ F) on the main PCB and make sure that the banded side of the capacitor is facing the + marking on the PCB (toward the front).

- a. Remove capacitor C31 (10 pF) from the main PCB.

- a. Install a 470  $\mu$ F, 35 volt electrolytic capacitor at C1 on the main PCB.
- b. Solder an insulated bus wire from the positive lead of C1 (toward R1) to the positive lead of C5 (toward VR4).

- a. Replace resistor R16 (10 k $\Omega$ ) with a 22 k $\Omega$  resistor.
- b. Replace resistor R6 (200 k $\Omega$ ) with a 6.8 k $\Omega$  resistor.
